DEGRADATION PROCESS OF ASPHALT CONCRETE LINING OF UPPER RESERVOIR IN ZARNOWIEC PUMPED STORAGE POWER PLANT

Stefan Bednarczyk, Remigiusz Duszyński¹, Piotr Książek²

Abstract: The paper deals with some faults and deficiencies of bituminous linings of the upper reservoir of the pumped storage power plant Zarnowiec. The heaves in the bottom of reservoir and the breaking of asphalt concrete lining upon the line of drains were described. The reasons of these phenomena were analysed and methods of renovation were characterised.

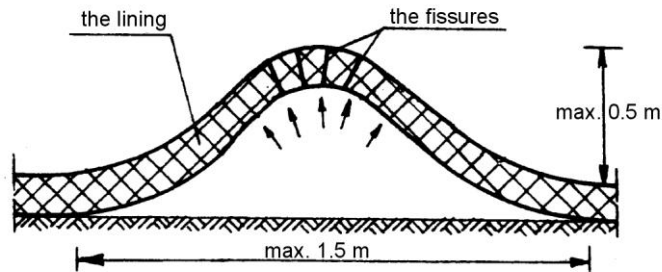
In June 1979, when near 70% of the reservoir bottom was covered with asphalt concrete, after sudden night rainfall many bottom heaves occurred (fig. 3). They have had maximum diameter of 150 cm and maximum height of 50 cm. Most of heaves have scratched or cracked on the top. The compressed air has flowed through those cracks.

The heaves were caused by two reasons. Firstly the atmospheric pressure had suddenly decreased for 12 hPa after 2 months of high barometric pressure. Secondly the drainage in

bottom part of slopes has been completely silted-up by fine parts of soil flushed with rainfalls. When the rain was falling the upper part of the slope was uncovered so the rainwater has flowed into drainage layer and toward into the soil under the bottom of the reservoir. Migration of water caused high pressure of air present in soil pores.

Fig. 3. The bottom air heave

The high difference between atmospheric and under bottom air pressure was the main reason of the damages. All heaves have appeared in those places, where the lining was thinner than 5 cm. Repairs were made by cutting of the heaves and making cork of the asphalt concrete (fig. 4b).

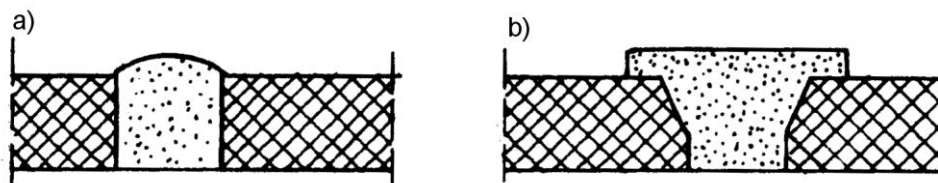
Fig. 4. Asphalt concrete cores in bottom lining a) incorrectly arranged, b) correctly arranged

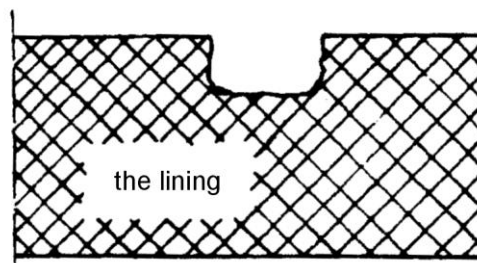
The large quantities of the smallpox (fig. 5) on the slope lining of the upper reservoir were confirmed after 10 years of Zarnowiec pumped storage power plant working. The smallpox was situated mainly in the area of the highest water level variation, nearby the joints, where the closing bituminous layer had not properly done.

Till now loosing some particles of basaltic grit causes the smallpox. The grits are washed-out by the water or ice.

Inadequate compaction of asphalt concrete mixture in the area of joints is the main reason of that kind of failures.

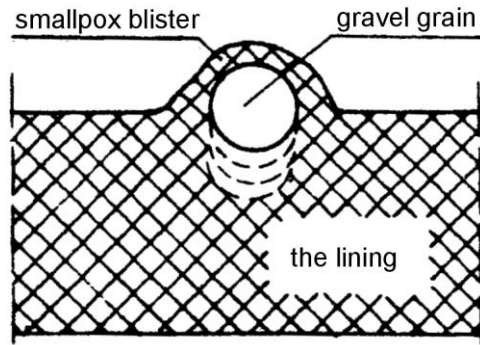
There are many smallpox blisters in the same area where the smallpox is situated. The gravel grits moving to the top surface of lining (fig. 6) cause the smallpox blisters. When the grip is out the big smallpox hole appears.
